project profile

Middleton Sea Wall

Hartlepool

Leromur

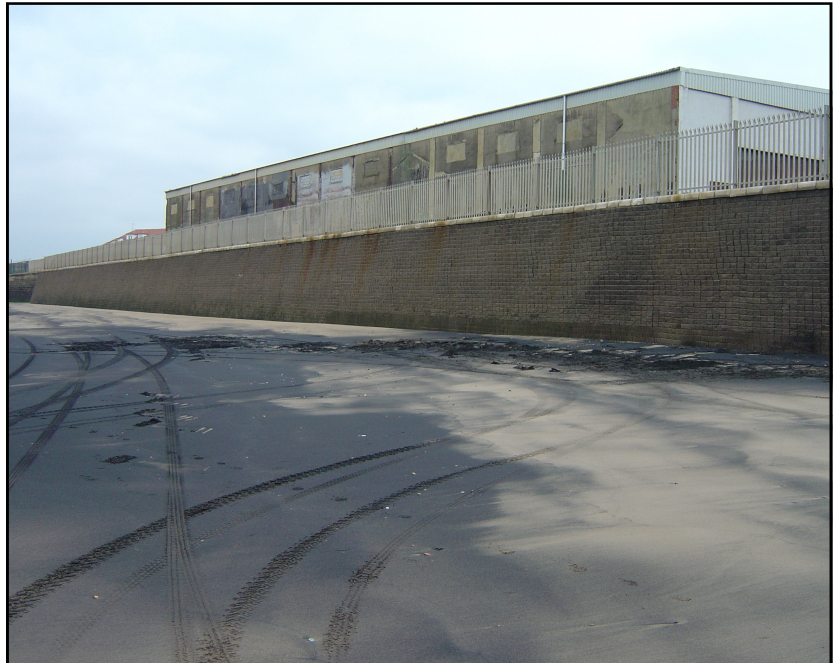
This tranquil photo perhaps does little to explain the circumstances around constructing this wall, but then it would be difficult to capture such a picture at high tide. The focus of this project was to armour an existing Larsen piled sea wall that had become badly holed by the effects of two tides per day in a bay where the aggressive wave action caused significant drift of beach material and debris much of it being infill from failing up-shore gabion defences that was being thrown against the face.

The solution was found with Leromur units beginning with a 1000mm wide lower structure featuring a smooth face, this being reduced after 1 metre to split faced sections of 750mm and 500mm width with a face angle of 15°. The gap between was infilled with low fines re-cycled aggregate reinforced laterally with Betonap geo-grids, the face of the piles being lined with a non-woven geo-textile. As the wall met the piles at the top level a pre-cast rollover coping was bonded in place.

The temporary works phase was a testing time with water inundation on two tides and a 1 metre shift in beach level. The solution was found by using Pecafil permanent shutters with a two stage concrete footing this firstly created an even bearing and then provided the reinforced base for the Leromur blocks. By using rapid hardening concrete it was possible to work between tides with a set achieved before vacating the beach. As the wall continued in height the dry laid structure came into its own by enabling tidal wash to over-top the structure but at the same time allowing water to permeate and then seep back through the dry joints on withdrawal.

Over 10 years have passed since the Betocalcul designed wall was completed, the welding that was then able to continue throughout the tides has now been completed, leaving the Leromur as a lasting monument to an engineering challenge that was successfully beaten.
