# project profile

Private residence

Leromur

Collapsed wall.

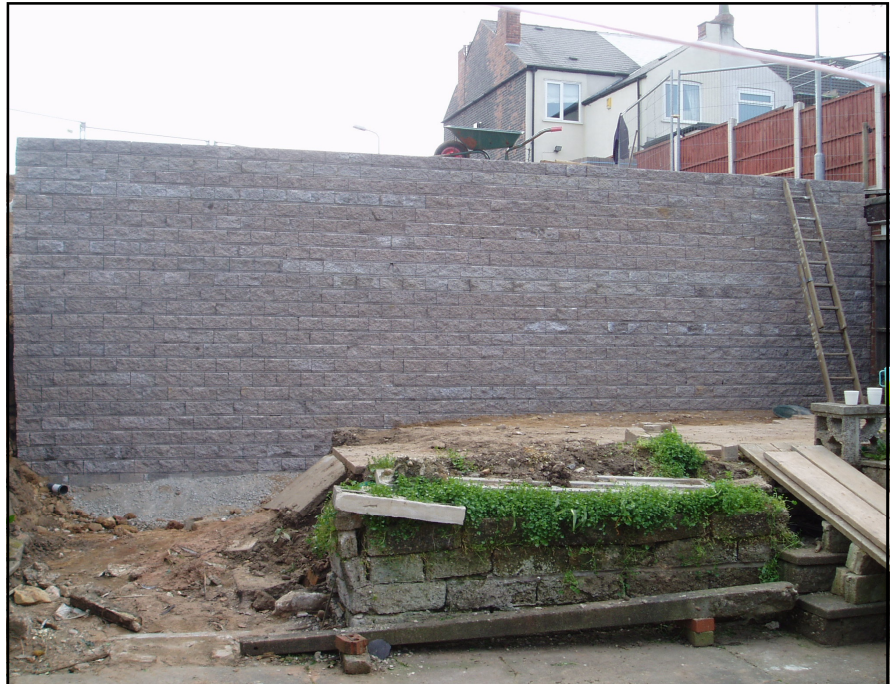
Such is the case with this domestic property where an existing re-constituted stone wall failed under the imposed load of a car park constructed at the higher level. The result a pile of rubble in a garden, the loss of a car park and one for the insurers to sort out!

The dry build Leromur system was selected with the 500mm wide split finish units combining with the woven Betonap geo-grids to form a composite mass wall structure with an almost vertical face of 87°. Once the foundation had been cast the work could begin on the 3.2 metre high wall, with the dry-laid units immediately able to retain and stabilise the slip. To the end of the wall a return end was created with the Leromur units to close off the backfill.
